**PROJECT** FEMA-1492-DR-MD High Water Mark Survey Project  
**COMM. NO.** 240064  
**TYPE** High Water Mark Survey **PREL.** 10/05/2003 **FINAL** 11/20/2003 **SHEET** L- 1  
**CONTENTS** Individual Historical High Water Mark Survey Report

**Historical Mark:** UNIT7\_13 **Mark Type:** Coastal  
**Flood Event:** Hurricane Isabel **Date of Flood:** 09/19/2003  
**Flooding Source:** Chesapeake Bay **Quality of Mark:** Fair  
**Flood Elevation:** **9.4 FT** **Location:** Debris line front yard  
**Flooding Type:** Wave runoff  
**Mark Address:** Route 1, Box 120, Tippet Road  
**Description of Mark:** debris line

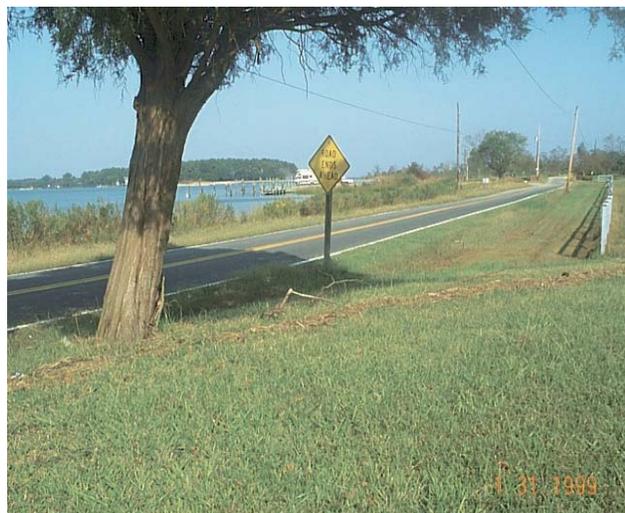
DCP\_3404.jpg

**Historical Mark:** UNIT7\_14 **Mark Type:** Coastal  
**Flood Event:** Hurricane Isabel **Date of Flood:** 09/19/2003  
**Flooding Source:** St. Jerome Creek/Chesapeake **Quality of Mark:** Fair  
**Flood Elevation:** **4.8 FT** **Location:** Ground/tree  
**Flooding Type:** Surge  
**Mark Address:** End of Airedele Road (in 2nd to last house yard)  
**Description of Mark:** flagged tree and ground with paint with nail and ribbon

Debris line may have been affected by weather or cleanup action, resulting in lower than average elevation.

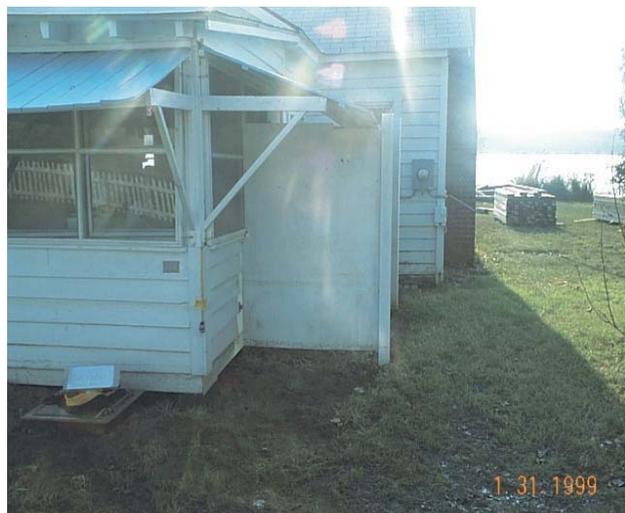
DCP\_3415.jpg

**Description of Mark:** front right corner below window on corner

**Type of Line:** Mud line

Mud line may have been affected by weather or cleanup action, resulting in lower than average elevation.

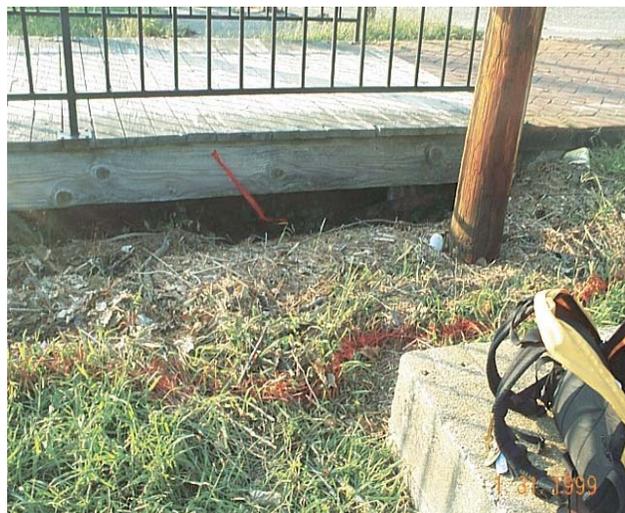
DCP\_3422.jpg

**Historical Mark:** UNIT7\_16 **Mark Type:** Coastal  
**Flood Event:** Hurricane Isabel **Date of Flood:** 09/19/2003  
**Flooding Source:** St. Mary's River **Quality of Mark:** Fair  
**Flood Elevation:** **4.8 FT** **Location:** Bridge/pole  
**Flooding Type:** Surge  
**Mark Address:** 16956 Look Out Road  
**Description of Mark:** a bridge next to public safety office

Debris line may have been affected by weather or cleanup action, resulting in lower than average elevation.

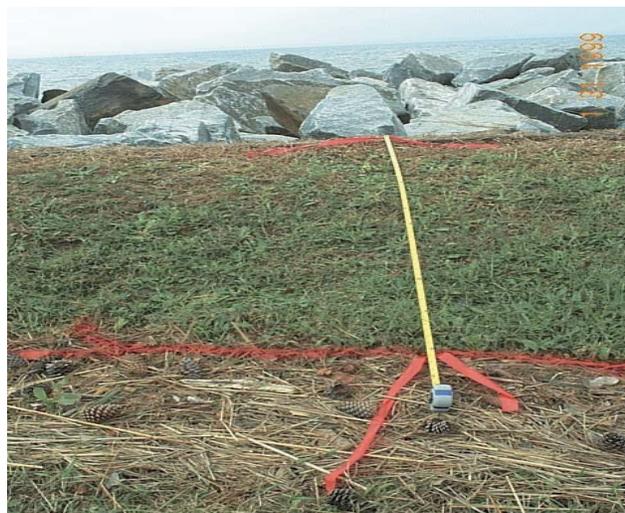
DCP\_3457.jpg

**Historical Mark:** UNIT7\_17 **Mark Type:** Coastal  
**Flood Event:** Hurricane Isabel **Date of Flood:** 09/19/2003  
**Flooding Source:** Potomac River **Quality of Mark:** Fair  
**Flood Elevation:** **6.5 FT** **Location:** Back of breaker wall  
**Flooding Type:** Surge  
**Mark Address:** 16608 Piney Point Road  
**Description of Mark:** debris line on back of breaker wall, across street from 16608

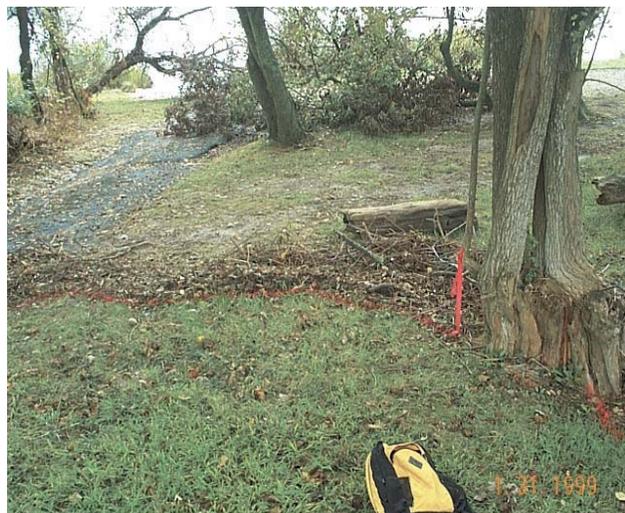
DCP\_3460.jpg

**Historical Mark:** UNIT7\_18 **Mark Type:** Coastal  
**Flood Event:** Hurricane Isabel **Date of Flood:** 09/19/2003  
**Flooding Source:** Breton Bay **Quality of Mark:** Fair  
**Flood Elevation:** **7.6 FT** **Location:** Ground/tree  
**Flooding Type:** Surge  
**Mark Address:** Public Park, at end of Camp Calvert Road at Boat Launch  
**Description of Mark:** debris line, with nail in tree for visual

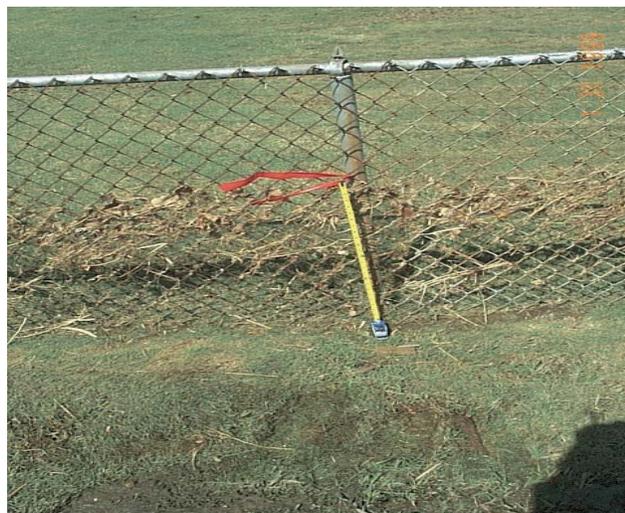
DCP\_3464.jpg

**Historical Mark:** UNIT7\_19 **Mark Type:** Coastal  
**Flood Event:** Hurricane Isabel **Date of Flood:** 09/19/2003  
**Flooding Source:** Potomac River **Quality of Mark:** Fair  
**Flood Elevation:** **7.3 FT** **Location:** Fence  
**Flooding Type:** Surge  
**Mark Address:** 38352 Point Breeze Road  
**Description of Mark:** fence in front of home

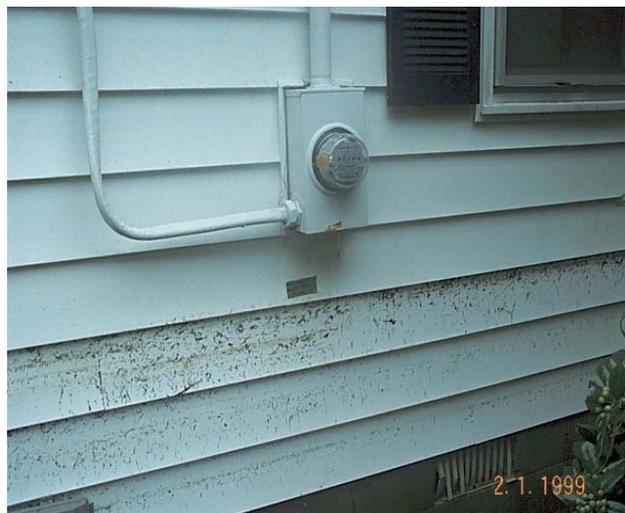
DCP\_3436.jpg

**Historical Mark:** UNIT7\_20 **Mark Type:** Coastal  
**Flood Event:** Hurricane Isabel **Date of Flood:** 09/19/2003  
**Flooding Source:** Potomac River **Quality of Mark:** Fair/Good  
**Flood Elevation:** **5.8 FT** **Location:** Outside building wall  
**Flooding Type:** Surge  
**Mark Address:** 40540 Old Breton Beach Road  
**Description of Mark:** front of building near air conditioning unit and electric meter

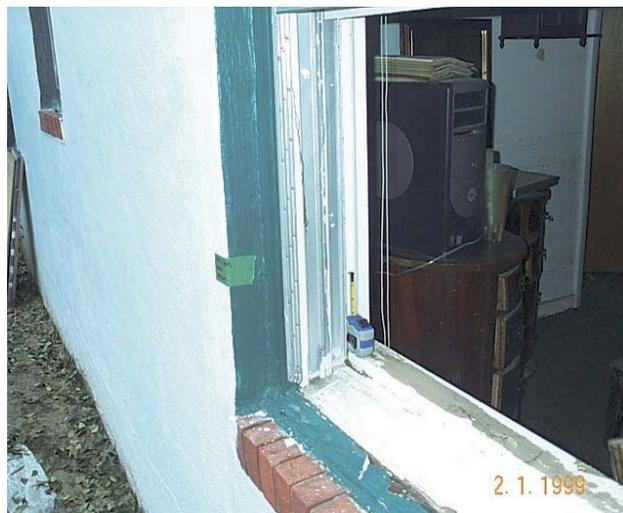
DCP\_3451.jpg

**Historical Mark:** UNIT7\_21 **Mark Type:** Coastal  
**Flood Event:** Hurricane Isabel **Date of Flood:** 09/19/2003  
**Flooding Source:** Potomac River **Quality of Mark:** Excellent  
**Flood Elevation:** **5.9 FT** **Location:** Inside wall/transfer  
**Flooding Type:** Surge  
**Mark Address:** 40461 Old Breton Beach Road  
**Description of Mark:** left side of home, front window, green tape

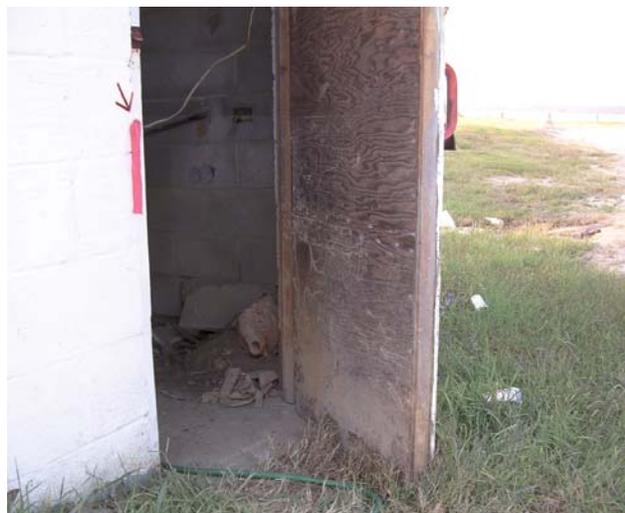
DSCN0078.jpg

**Historical Mark:** UNIT9\_6 **Mark Type:** Coastal  
**Flood Event:** Hurricane Isabel **Date of Flood:** 09/19/2003  
**Flooding Source:** Patuxent River **Quality of Mark:** Good  
**Flood Elevation:** **5 FT** **Location:** inside wall transferred out  
**Flooding Type:** Surge  
**Mark Address:** 27130 South Sandgates Rd (Seabreeze Restaurant)  
**Description of Mark:** 35" from top of concrete slab

HWM is on left side of wooden door frame. Transferred from interior mud line. Mud line may have been affected by weather or cleanup action, resulting in lower than average elevation.

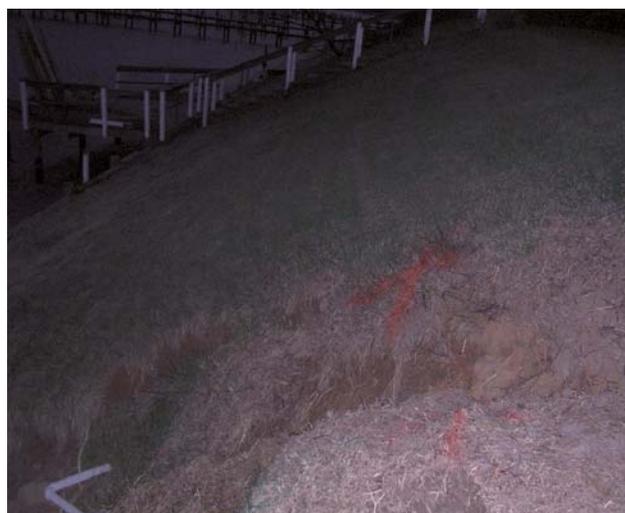
DSCN0084.jpg

**Historical Mark:** UNIT9\_7 **Mark Type:** Coastal  
**Flood Event:** Hurricane Isabel **Date of Flood:** 09/19/2003  
**Flooding Source:** Patuxent River **Quality of Mark:** Poor  
**Flood Elevation:** **11.2 FT** **Location:** ground  
**Flooding Type:** Wave height  
**Mark Address:** 24239 N. Patuxent Beach Rd  
**Description of Mark:** did not determine

Homeowner described the debris line as being even with the 2nd handrail post from top of staircase, visible in background of photo 0084. This was verified with a photo taken the day after the storm. Staircase is on neighbor's property. Bulkheads along this reach of shoreline did not perform well; this particular property sustained major shoreline erosion/scour behind an old wooden bulkhead that completely failed. SURVEYOR: proceed with caution as HWM is adjacent to eroded shoreline.
