Hazard Mitigation Technical Assistance Program  
Contract No. EMW-2000-CO-0247  
**Task Orders 276 and 279**  
**Hurricane Isabel Rapid Response**  
**Coastal High Water Mark (CHWM) Collection**  
FEMA-1492-DR-MD

**Final Report**  
November 19, 2003

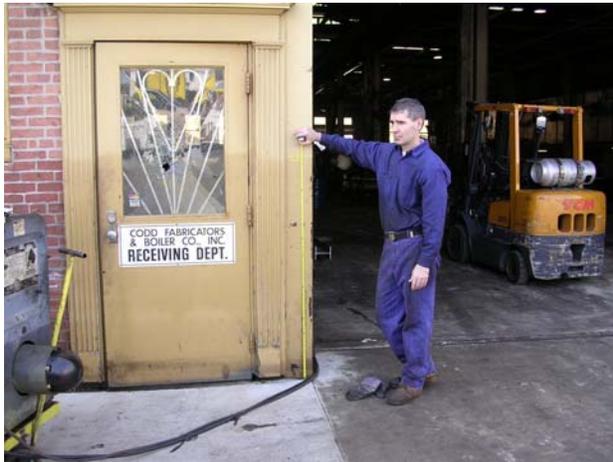
**Figure 3: CHWM in Baltimore County**

In general, Hurricane Isabel produced more extensive flooding from storm surge and coastal stillwater flooding than from riverine flooding from heavy rains as the storm moved inland. Excessive damage was witnessed in many communities located along the Chesapeake Bay and coastlines on inland waterways. Many structures were destroyed as a result of the storm surge. Despite widespread power outages and lack of water in most coastal communities, field crews did not encounter any significant constraints to access. Figures 3 and 4 below are photos of 2 CHWMs collected after Hurricane Isabel.
