PROJECT: FEMA - 1539 - DR - FL Coastal High Water Mark Survey Project

CONTENTS: Individual Historical High Water Mark Survey Report

TYPE: High Water Mark Survey

HWM ID: Unit3_1 **Type of Mark:** red paint on seawall

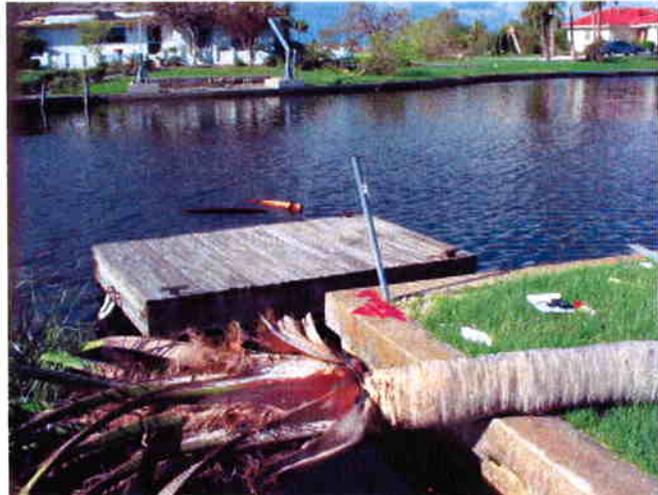
unit3_1.jpg

Location of HWM Object: Point located 6 inches down from top of seawall, at NE corner of indentation in seawall. Marked with red spray paint. 6 inches down from top of seawall.

point located 6 inches down from top of seawall. Line located ~ 1 foot above current water level. Tide was almost at low stage
