**PROJECT:** FEMA - 1539 - DR - FL Coastal High Water Mark Survey Project  
**CONTENTS:** Individual Historical High Water Mark Survey Report  
**TYPE:** High Water Mark Survey  
**COMM. NO.** 125124 **PREL.** 10/18/2004 **FINAL** 11/4/2004 **SHEET** Lee-39

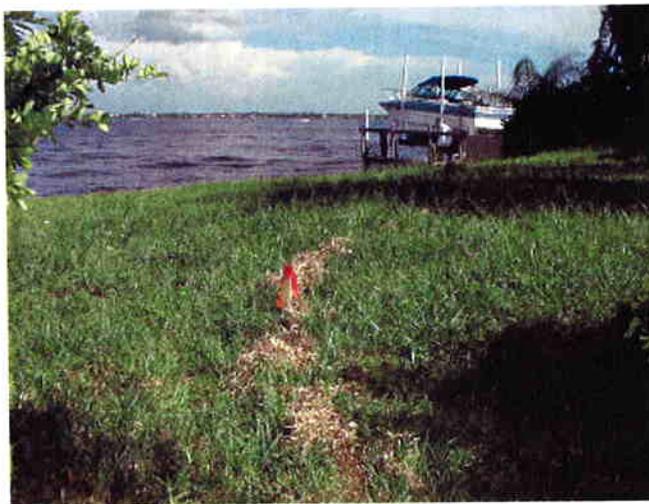
unit4\_30.jpg

**HWM ID:** Unit4\_30 **Type of Mark:** stave  
**Name of Storm Event:** Hurricane Charley **Date of Flood Event:** 8/13/2004  
**Stream Name/Flood Source:** Matalacha Pass **Quality of Mark:** fair  
**Survey Elevation (NAVD 88):** 3.27 ft **NGVD 29:** 4.45 ft **HWM Object:** lawn  
**Flooding Type:** wave runup  
**HWM Address:** southern end of SW 1st Ct.  
**Location of HWM Object:** souther end of SW 1st Ct

**HWM Type:** debris line  
**Closest Municipality:** Cape Coral **County:** Lee **State:** Fl
