**PROJECT:** Hurricane Ivan, 1551 DR - Florida  
**CONTENTS:** Individual Historical High Water Mark Survey Report  
**TYPE:** High Water Mark Survey  
**COMM. NO.** 120274      **PREL.** 11/10/2004      **FINAL** 12/23/2004      **SHEET** Sant-9

**HWM ID:** UnitF5\_10      **Type of Mark:** Red mark  
**Name of Storm Event:** Ivan      **Date of Flood Event:** 9/16/2004  
**Stream Name/Flood Source:** East Bay      **Quality of Mark:** Good  
**Survey Elevation (NAVD 88):** 10.7 ft      **NGVD 29: 10.9 ft**      **HWM Object:** Inside wall of shower  
**Flooding Type:** Surge  
**HWM Address:** 6407 Glory Ave./1261 Vista Del Mar, Milton, FL 32583  
**Location of HWM Object:** In bath off garage.

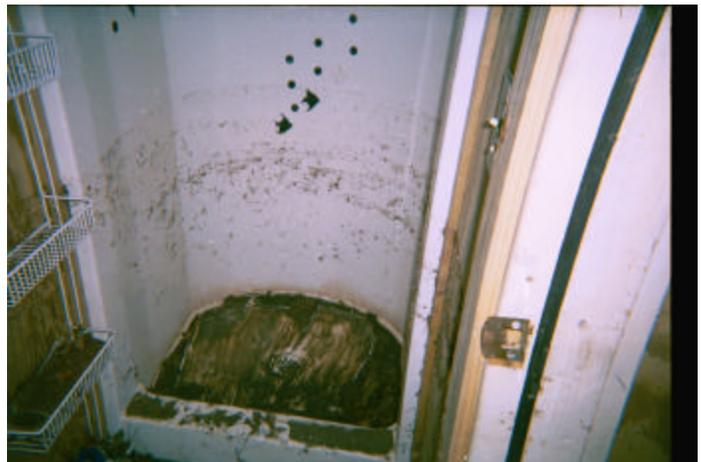
UnitF5\_10.jpg

**HWM Type:** Mud line in bath shower  
**Closest Municipality:** Milton, FL      **County:** Santa Rosa      **State:** FL
