PROJECT: Hurricane Ivan, 1551 DR - Florida
CONTENTS: Individual Historical High Water Mark Survey Report
TYPE: High Water Mark Survey
COMM. NO. 12091C **PREL.** 11/10/2004 **FINAL** 12/23/2004 **SHEET** Okal-9

HWM ID: UnitF6_10 **Type of Mark:** Top of deck
Name of Storm Event: Ivan **Date of Flood Event:** 9/16/2004
Stream Name/Flood Source: Gulf surge into intercoastal waterway **Quality of Mark:** Good
Survey Elevation (NAVD 88): 10.2 ft **NGVD 29:** 10.6 ft **HWM Object:** Deck off south side of house, top of wood deck
Flooding Type: Surge
HWM Address: 18 Misty Water Lane, Mary Ester, FL
Location of HWM Object: Top of west end of deck.

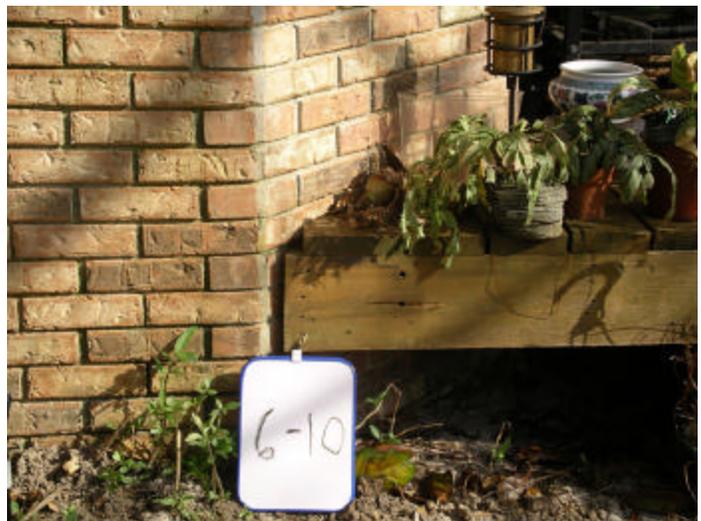
UnitF6_10.jpg

Homeowner saw Gulf water flowing over Okaloosa Island and photographed the water level at the top of his deck.
