PROJECT: Hurricane Ivan, 1551 DR - Florida
CONTENTS: Individual Historical High Water Mark Survey Report
TYPE: High Water Mark Survey
COMM. NO. 120274 **PREL.** 11/10/2004 **FINAL** 12/23/2004 **SHEET** Sant-13

HWM ID: UnitF6_29 **Type of Mark:** Water line
Name of Storm Event: Ivan **Date of Flood Event:** 9/16/2004
Stream Name/Flood Source: East Bay **Quality of Mark:** Fair
Survey Elevation (NAVD 88): 8.8 ft **NGVD 29: 9.1 ft** **HWM Object:** Yard facing north east bay
Flooding Type: Surge
HWM Address: 5588 East Bay Blvd
Location of HWM Object: Yard.

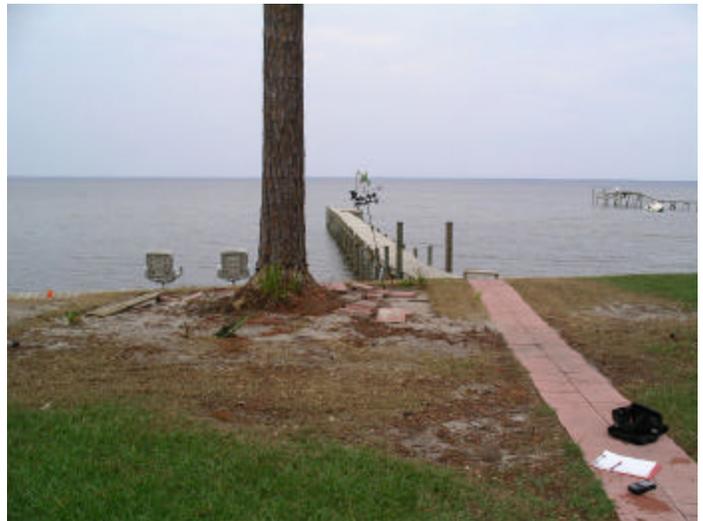
UnitF6_29b.jpg

HWM Type: Water mark on grass - debris line
Closest Municipality: Navarre **County:** Santa Rosa **State:** FL
