PROJECT: Hurricane Ivan, 1551 DR - Florida
CONTENTS: Individual Historical High Water Mark Survey Report
TYPE: High Water Mark Survey
COMM. NO. 12091C **PREL.** 11/10/2004 **FINAL** 12/23/2004 **SHEET** Okal-25

HWM ID: UnitF6_32 **Type of Mark:** N/A
Name of Storm Event: Ivan **Date of Flood Event:** 9/16/2004
Stream Name/Flood Source: Gulf of Mexico **Quality of Mark:** Fair
Survey Elevation (NAVD 88): 7.7 ft **NGVD 29:** 8.1 ft **HWM Object:** Near isolated pine tree
Flooding Type: Surge
HWM Address: Hwy 98 between Destin and Ft. Walton
Location of HWM Object: North of Hwy 98, west bound lane on sand dune.
HWM Type: Debris line
Closest Municipality: Destin **County:** Okaloosa **State:** FL
Name of Flagger/Interviewer: Sroufe **Flagger Company:** URS
Date of Flagging/Interview: 10/7/2004
Survey Crew: Keith (Dallas) **Survey Company:** PBS & J
Survey Date: 10/31/2004
Survey Projection: State Plane Feet Florida North **Vertical Datum:** NAVD 88 **Horizontal Datum:** NAD 83
Easting (Meters): 403301.70493 **Easting (feet):** 1323165.677
Survey Latitude: 30.39252 **Northing (Meters):** 156124.7268 **Northing (feet):** 512219.2078

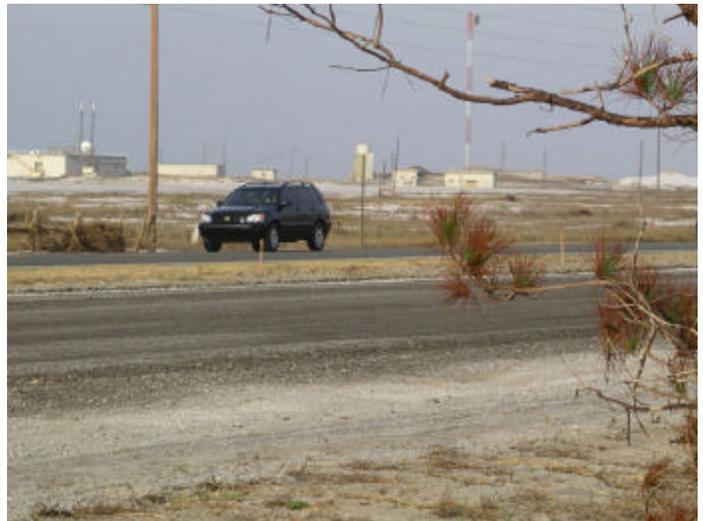
UnitF6_32c.jpg

Sand dunes are missing in this area and debris was found past the fence extending on to military property.
