PROJECT: Hurricane Ivan, 1551 DR - Florida
CONTENTS: Individual Historical High Water Mark Survey Report
TYPE: High Water Mark Survey
COMM. NO. 12091C **PREL.** 11/10/2004 **FINAL** 12/23/2004 **SHEET** Okal-4

HWM ID	UnitF6_4	Type of Mark:	Water stain
Name of Storm Event:	Ivan	Date of Flood Event:	9/16/2004
Stream Name/Flood Source:	Gulf of Mexico	Quality of Mark:	Good
Survey Elevation (NAVD 88):	5.5 ft NGVD 29: 5.9 ft	HWM Object:	High water mark stain on sheetrock
Flooding Type:	Surge		
HWM Address:	365 Gulfshore Drive #4		
Location of HWM Object	Right side of garage.		
HWM Type:	Water mark in garage		
Closest Municipality:	Destin	County Okaloosa	State: FL
Name of Flagger/Interviewer:	Sroufe	Flagger Company:	URS
Date of Flagging/Interview:	10/1/2004		
Survey Crew:	Keith (Dallas)	Survey Company:	PBS & J
Survey Date:	10/23/2004		
Survey Projection:	State Plane Feet Florida North	Vertical Datum:	NAVD 88 Horizontal Datum: NAD 83
		Easting (Meters):	407421 Easting (feet): 1336680
Survey Latitude:	30.38822	Northing (Meters):	155575.1 Northing (feet): 510416.1
Survey Longitude:	86.50394	Approx. First Floor Elevation:	N/A

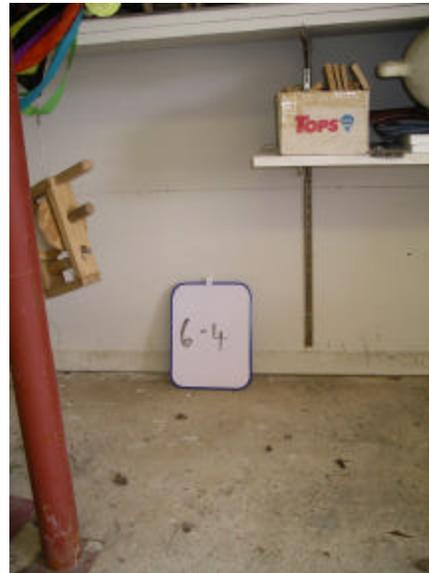
UnitF6_4.jpg

This is condominium, all condos were wet with water from the Gulf. These condos are located on the north side of the island.
