**PROJECT:** Hurricane Ivan, 1551 DR - Florida  
**CONTENTS:** Individual Historical High Water Mark Survey Report  
**TYPE:** High Water Mark Survey  
**COMM. NO.** 12033C      **PREL.** 11/10/2004    **FINAL** 12/23/2004    **SHEET** Esca-21

**HWM ID:** UnitF7\_21      **Type of Mark:** Duct tape  
**Name of Storm Event:** Ivan      **Date of Flood Event:** 9/16/2004  
**Stream Name/Flood Source:** Pensacola Bay      **Quality of Mark:** Good  
**Survey Elevation (NAVD 88):** 11.5 ft      **NGVD 29:** 11.8 ft      **HWM Object:** Interior garage door transferred to garage door frame  
**Flooding Type:** Surge  
**HWM Address:** 510 Windrose Circle  
**Location of HWM Object:** West end of house.

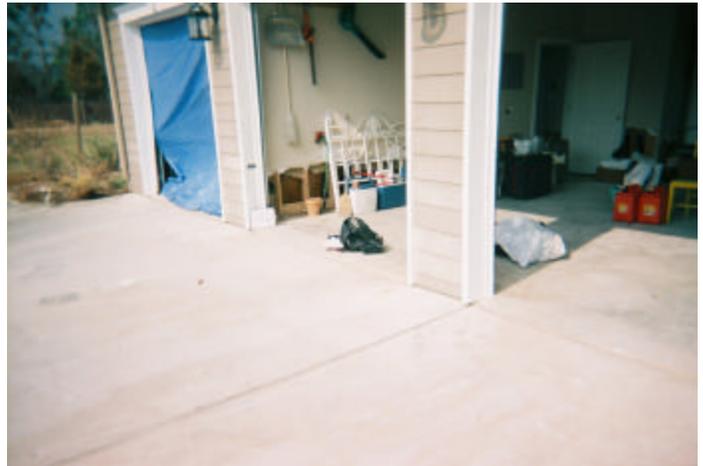
UnitF7\_21.jpg

**HWM Type:** Mud line  
**Closest Municipality:** Pensacola      **County:** Escambia      **State:** FL
