PROJECT: Hurricane Ivan, 1551 DR - Florida
CONTENTS: Individual Historical High Water Mark Survey Report
TYPE: High Water Mark Survey
COMM. NO. 120274 **PREL.** 11/10/2004 **FINAL** 12/23/2004 **SHEET** Esca-25

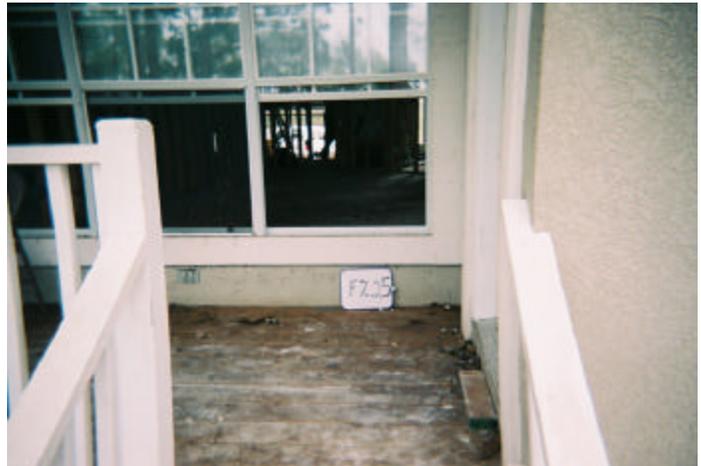
UnitF7_25.jpg

HWM ID: UnitF7_25 **Type of Mark:** Duct tape
Name of Storm Event: Ivan **Date of Flood Event:** 9/16/2004
Stream Name/Flood Source: Escambia Bay **Quality of Mark:** Good
Survey Elevation (NAVD 88): 13.0 ft **NGVD 29:** 13.3 ft **HWM Object:** Back window transferred to back deck
Flooding Type: Surge
HWM Address: 4356 Bayside Blvd., Milton, FL
Location of HWM Object: Back deck on west side of house.

HWM Type: Mud line
Closest Municipality: Pensacola **County:** Escambia **State:** FL
