PROJECT: Hurricane Ivan, 1551 DR - Florida
CONTENTS: Individual Historical High Water Mark Survey Report
TYPE: High Water Mark Survey
COMM. NO. 12033C **PREL.** 11/10/2004 **FINAL** 12/23/2004 **SHEET** Esca-45

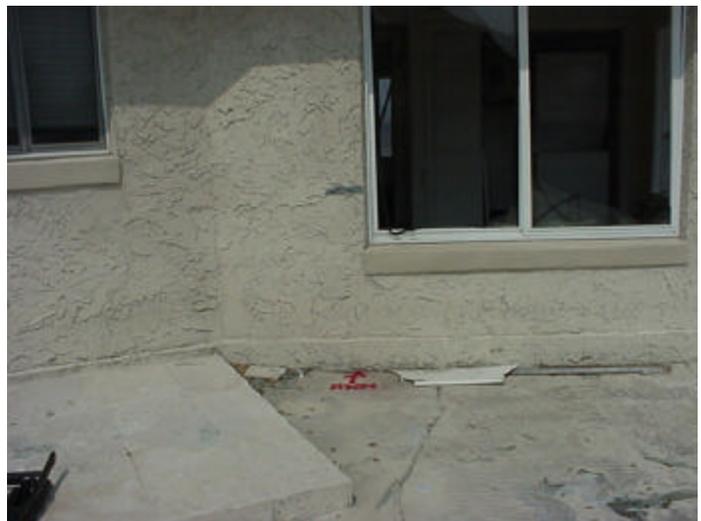
UnitF8_8.jpg

HWM ID: UnitF8_8 **Type of Mark:** Duct tape
Name of Storm Event: Ivan **Date of Flood Event:** 9/16/2004
Stream Name/Flood Source: Santa Rosa Sound **Quality of Mark:** Good
Survey Elevation (NAVD 88): 7.6 ft **NGVD 29:** 7.9 ft **HWM Object:** Interior water line transferred to exterior wall on SE side of house to right of the front door
Flooding Type: Surge
HWM Address: 815 Rio Vista Dr
Location of HWM Object: Exterior wall to the right of the front door.

This house and most others in area are slab on grade and experienced major interior flooding.
