**PROJECT:** Hurricane Ivan, 1551 DR - Florida  
**CONTENTS:** Individual Historical High Water Mark Survey Report  
**TYPE:** High Water Mark Survey  
**COMM. NO.** 12005C **PREL.** 11/10/2004 **FINAL** 12/23/2004 **SHEET** Bay-1

**HWM ID:** UnitF9\_15 **Type of Mark:** Stake and flag  
**Name of Storm Event:** Ivan **Date of Flood Event:** 9/16/2004  
**Stream Name/Flood Source:** Intercoastal waterway **Quality of Mark:** Good

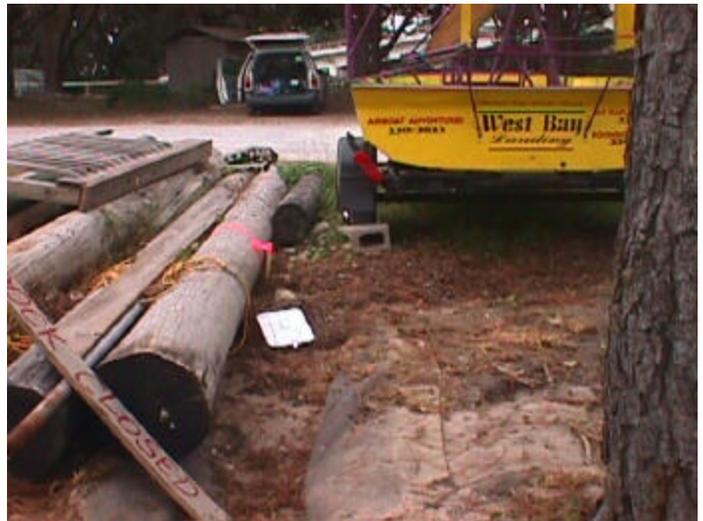
UnitF9\_15.jpg

**Survey Elevation (NAVD 88):** 2.9 ft **NGVD 29:** 3.4 ft **HWM Object:** Ground  
**Flooding Type:** Run-up  
**HWM Address:** 14856 Bay View Circle  
**Location of HWM Object:** When looking toward intercoastal waterway, the stake and flag are to the left of some pilings laying on the ground.

**HWM Type:** Debris line  
**Closest Municipality:** West Bay **County:** Bay **State:** FL  
**Name of Flagger/Interviewer:** Phillips **Flagger Company:** URS
