PROJECT FEMA-1492-DR-MD High Water Mark Survey Project
COMM. NO. 240009
TYPE High Water Mark Survey **PREL.** 10/05/2003 **FINAL** 11/20/2003 **SHEET** A-1
CONTENTS Individual Historical High Water Mark Survey Report

Historical Mark: UNIT4_1 **Mark Type:** Coastal
Flood Event: Hurricane Isabel **Date of Flood:** 09/19/2003
Flooding Source: Spa Creek/Severn River **Quality of Mark:** Fair
Flood Elevation: **6.5 FT** **Location:** outside building window
Flooding Type: Surge
Mark Address: 69 Prince George Street
Description of Mark: 6.75" above window sill to right of door. Sign on door reads "use side door"

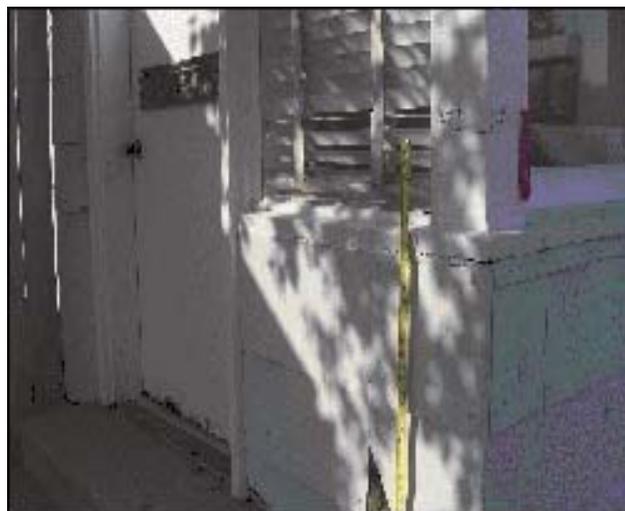
DSCN0005.jpg

Type of Line: Mud/debris line

point located under tree so exact positioning may be difficult. Time = 4:45 pm. Weather = Sunny + Clear.

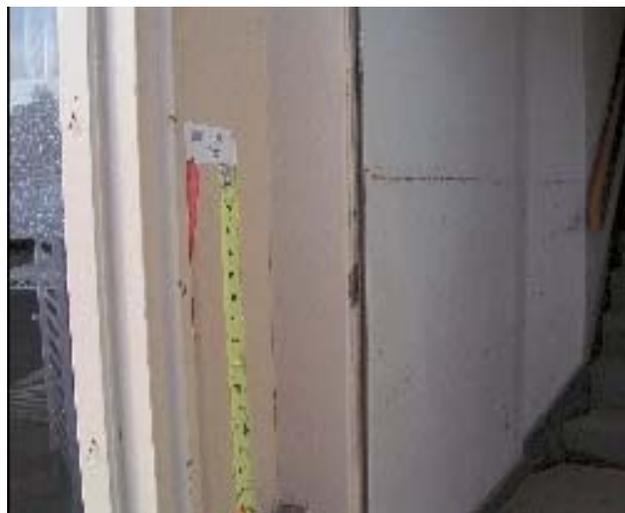
DSCN0006.jpg

Historical Mark: UNIT4_2 **Mark Type:** Coastal
Flood Event: Hurricane Isabel **Date of Flood:** 09/19/2003
Flooding Source: Spa Creek/Severn River **Quality of Mark:** Good
Flood Elevation: **6.3 FT** **Location:** Inside Wall
Flooding Type: Surge
Mark Address: 122 Dock Street
Description of Mark: 21.5" above top of brick foundation

Type of Line: Debris line

Witness was present for flooding associated with both hurricane of 1933 and Hurricane Isabel. Mark transferred to outside wall.

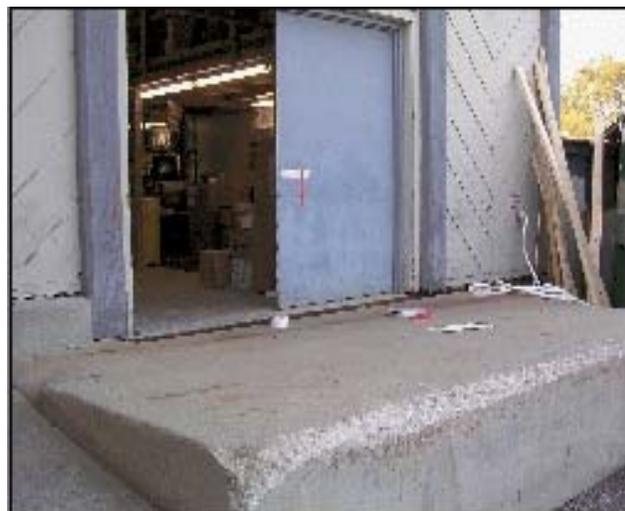
DSCN0007.jpg

Flood Elevation: **6.4 FT** **Location:** Inside Wall

Description of Mark: 35.25" from top of concrete slab against door

Type of Line: Mud/debris line

Photo ID 0009 shows flooding inside the building. HWM transferred to outside door.

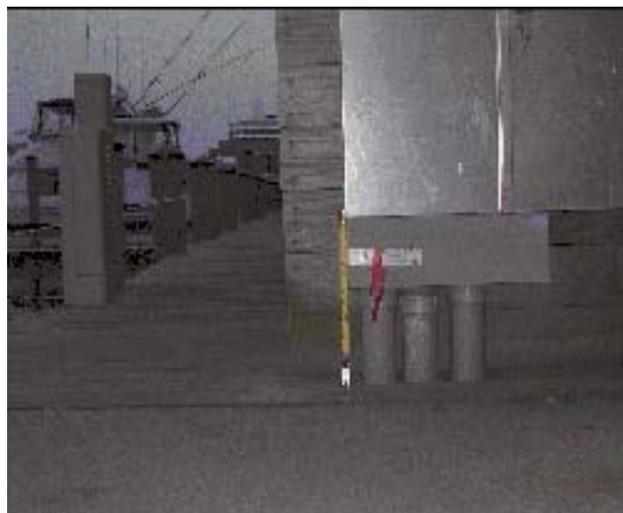
DSCN0013.jpg

Historical Mark: UNIT4_4 **Mark Type:** Coastal
Flood Event: Hurricane Isabel **Date of Flood:** 09/19/2003
Flooding Source: Spa Creek/Severn River **Quality of Mark:** Poor
Flood Elevation: **5.5 FT** **Location:** metal utilities box
Flooding Type: Surge
Mark Address: 2 Compromise Street (Annapolis Yacht Club)
Description of Mark: 13.75 inches above dock; approx. 4 ft above water level @ 6:52 pm.

Type of Line: Debris line

debris line was very pronounced, but HWM received poor rating because it seemed to be left when surge was receding and not at peak. Eyewitness accounts at the Yacht Club estimated the water level to be much higher (approx 2 feet).

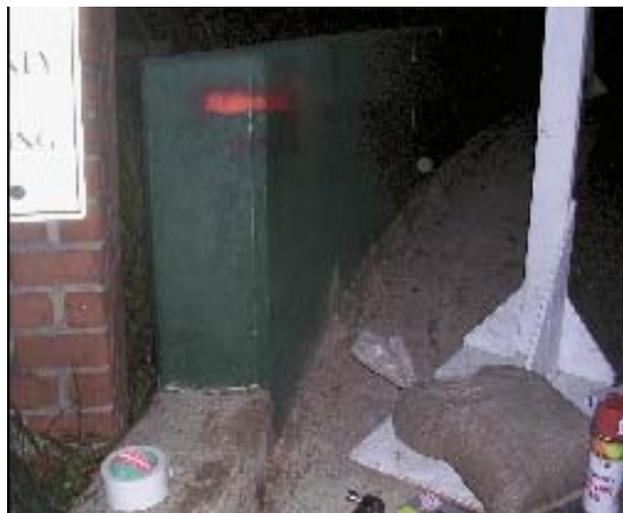
DSCN0014.jpg

Historical Mark: UNIT4_5 **Mark Type:** Coastal
Flood Event: Hurricane Isabel **Date of Flood:** 09/19/2003
Flooding Source: Spa Creek/Severn River **Quality of Mark:** Fair
Flood Elevation: **6.1 FT** **Location:** outside wall
Flooding Type: Surge
Mark Address: 80 Compromise Street (Annapolis Marriott Waterfront)
Description of Mark: 25.75" above access ramp surface

Type of Line: Mud line

Survey should be taken at bottom of paint line.

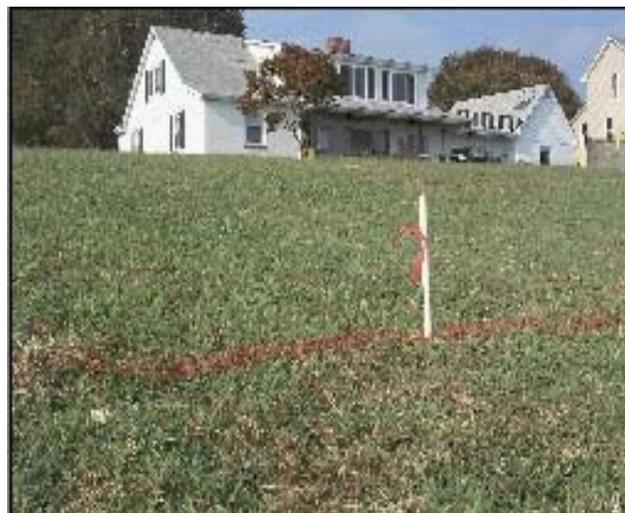
DSCN0021.jpg

Historical Mark: UNIT4_6 **Mark Type:** Coastal
Flood Event: Hurricane Isabel **Date of Flood:** 09/19/2003
Flooding Source: Chesapeake Bay **Quality of Mark:** Fair
Flood Elevation: **7.6 FT** **Location:** ground
Flooding Type: Surge
Mark Address: 2103 Bay Drive
Description of Mark: approx 2 feet above crest of seawall

Type of Line: Debris line

Time: 9:45 a.m. Weather: Clear and sunny.
SURVEYOR: take elevation of ground @stake/paint line

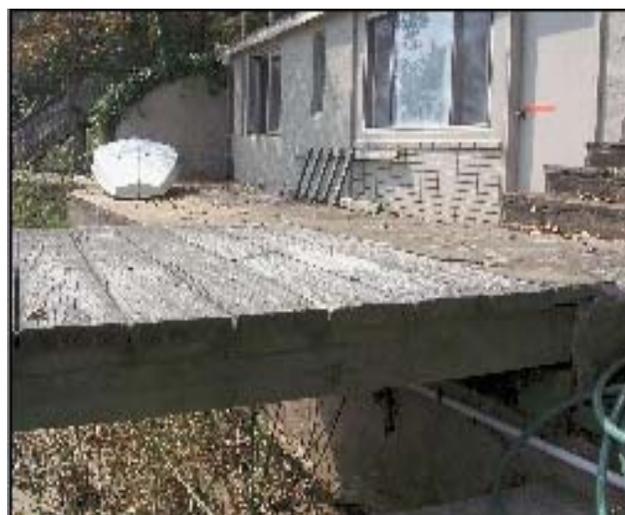
Historical Mark: UNIT4_7 **Mark Type:** Coastal
Flood Event: Hurricane Isabel **Date of Flood:** 09/19/2003
Flooding Source: Whitehall Creek **Quality of Mark:** Good
Flood Elevation: **6.5 FT** **Location:** inside wall*
Flooding Type: Surge
Mark Address: 824 Holly Drive East
Description of Mark: 35.125" above concrete slab inside dockhouse

Type of Line: Mud/debris line

Time: 12:00 p.m. **HWM transferred to outside of door. Water level was 49.5" from top of dock. Dock approx 10" above concrete slab in front of dockhouse.

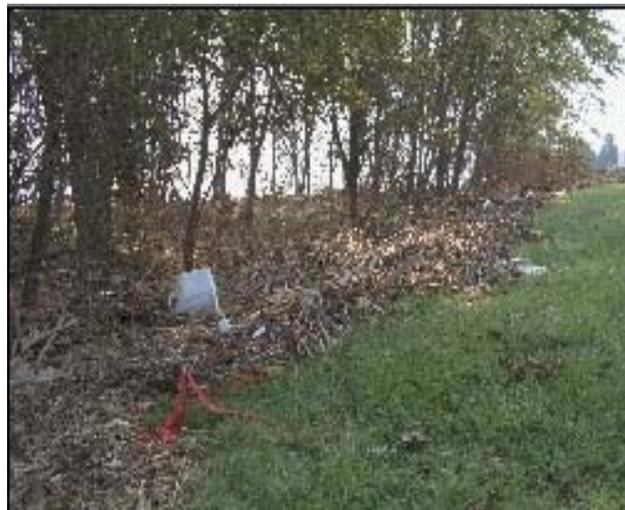
DSCN0034.jpg

Historical Mark: UNIT4_8 **Mark Type:** Coastal
Flood Event: Hurricane Isabel **Date of Flood:** 09/19/2003
Flooding Source: Chesapeake Bay **Quality of Mark:** Fair
Flood Elevation: **7.2 FT** **Location:** ground
Flooding Type: Surge
Mark Address: 895 Oceanic Drive (Northrop Grumman Corporation)
Description of Mark: HORIZONTAL DISTANCE: 16' 1" from edge of sidewalk (ground elevation at this point)

Type of Line: Debris line

Survey elevation of ground at stake/paint line.

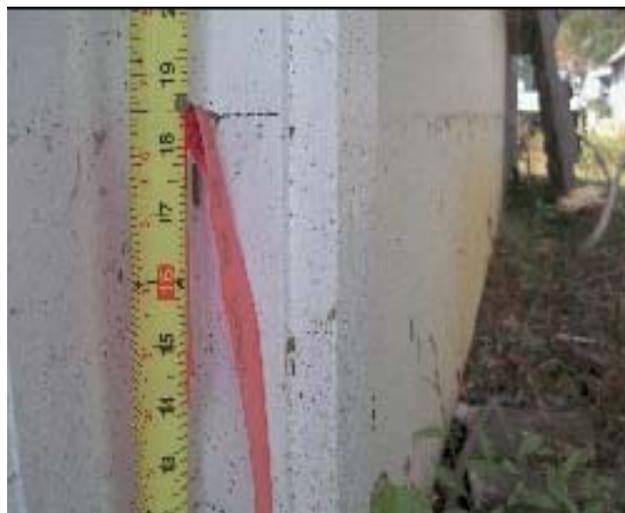
DSCN0037.jpg

Historical Mark: UNIT4_9 **Mark Type:** Coastal
Flood Event: Hurricane Isabel **Date of Flood:** 09/19/2003
Flooding Source: Meredith Creek **Quality of Mark:** Good
Flood Elevation: **6.2 FT** **Location:** outside wall
Flooding Type: Surge
Mark Address: 1729 River Rd
Description of Mark: 18.5" from top of garage slab inside door frame

Type of Line: Mud/debris line

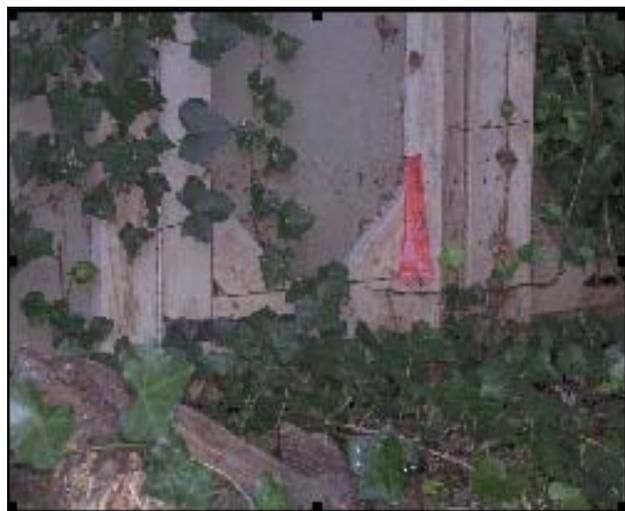
DSCN0039.jpg

Historical Mark: UNIT4_10 **Mark Type:** Coastal
Flood Event: Hurricane Isabel **Date of Flood:** 09/19/2003
Flooding Source: Burley Creek **Quality of Mark:** Fair
Flood Elevation: **6.5 FT** **Location:** outside wall
Flooding Type: Surge
Mark Address: 1829 Hidden Point Rd
Description of Mark: 7.625" above brace in door frame on wooden shed behind residence

Type of Line: Debris line

Time: 3:40 p.m. WSEL was 29.5" below crest of bulkhead. HWM approx 2' above crest of bulkhead.

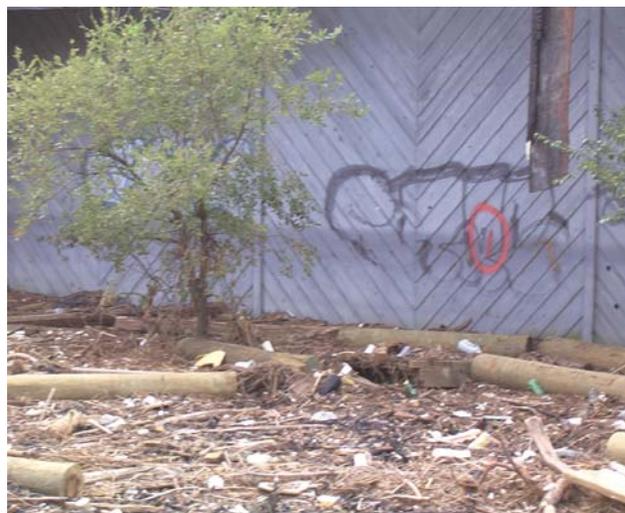
Historical Mark: UNIT4_11 **Mark Type:** Coastal
Flood Event: Hurricane Isabel **Date of Flood:** 09/19/2003
Flooding Source: Severn River **Quality of Mark:** Fair
Flood Elevation: **6.8 FT** **Location:** outside building wall
Flooding Type: Surge
Mark Address: No address
Description of Mark: 80.25" below 2x4 (top wall frame) in middle of building

Type of Line: Mud/debris line

Building is condemned. Parking lot is littered with debris.

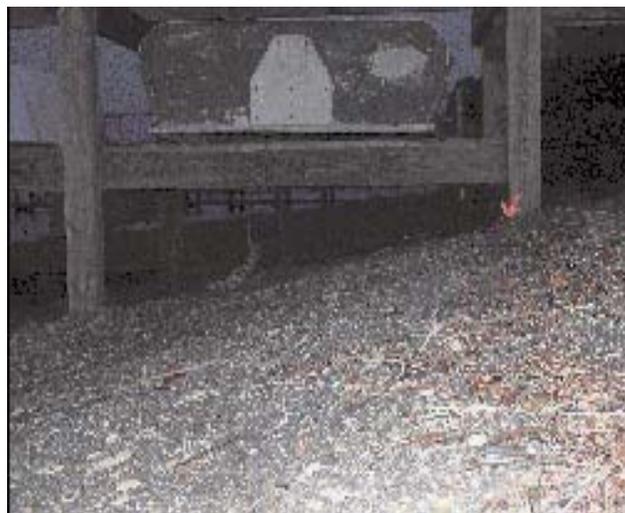
DSCN0047.jpg

Historical Mark: UNIT4_12 **Mark Type:** Coastal
Flood Event: Hurricane Isabel **Date of Flood:** 09/19/2003
Flooding Source: Severn River **Quality of Mark:** Fair
Flood Elevation: **7 FT** **Location:** post on canoe rack
Flooding Type: Surge
Mark Address: Dream's Landing condo community
Description of Mark: approx 2" above pavement surface, measured at front of post.

Type of Line: Debris line/personal account

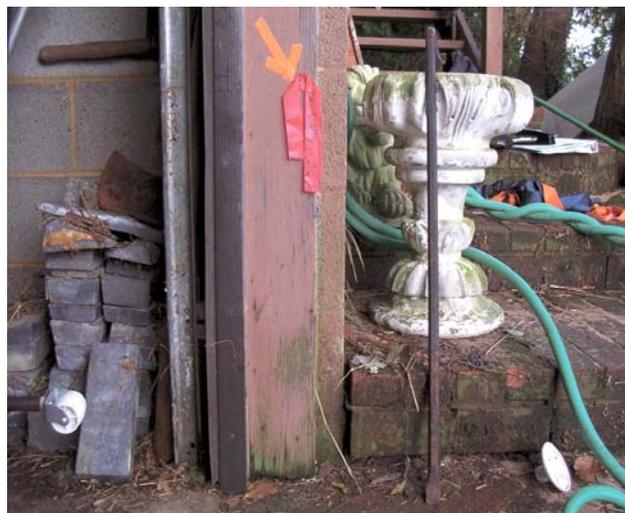
DSCN0050.jpg

Flood Elevation: **6.4 FT** **Location:** inside wall

Description of Mark: approx 27.25" above top of brick driveway, measured inside garage door frame

Type of Line: Debris line

*HWM transferred to outside. Time: 8:00 a.m. Weather: some fog

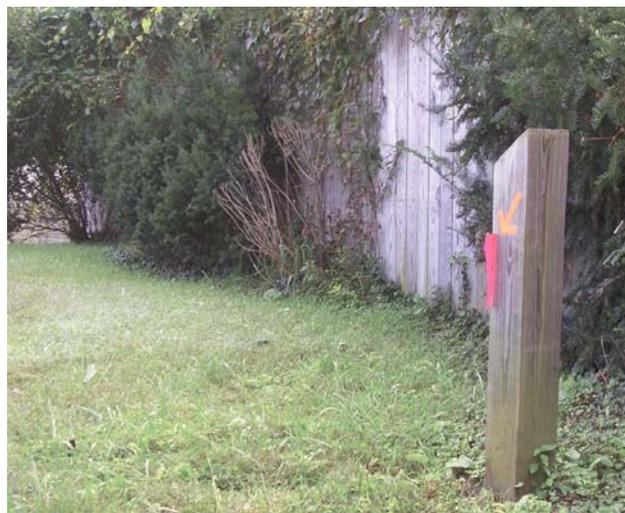
DSCN0054.jpg

Historical Mark: UNIT4_14 **Mark Type:** Coastal
Flood Event: Hurricane Isabel **Date of Flood:** 09/19/2003
Flooding Source: Severn River **Quality of Mark:** Fair
Flood Elevation: **6.6 FT** **Location:** wooden post
Flooding Type: Surge
Mark Address: Beach 2, Arden on the Severn
Description of Mark: approx 7" below water side of top of post

Type of Line: Debris line

HWM transferred from debris line in shrubs. Time: 9:40 a.m. Weather: mostly cloudy.

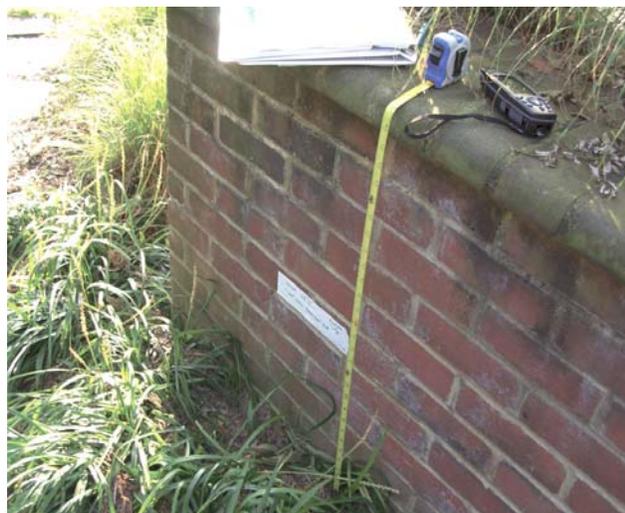
DSCN0005.jpg

HWM transferred from inside. Mud line measured at approx. 40" above basement slab.

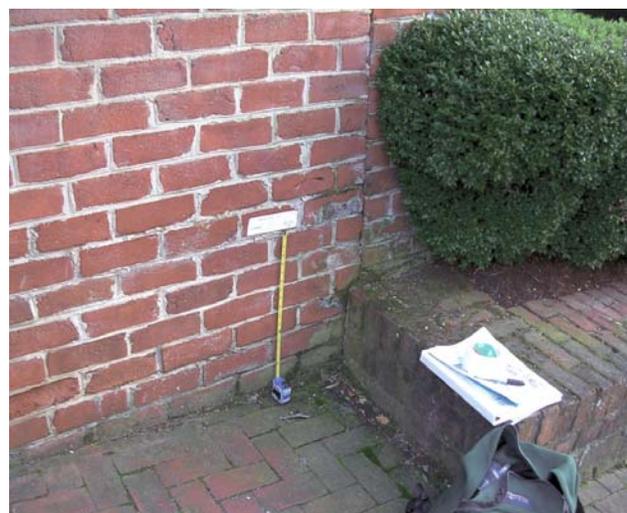
DSCN0008.jpg

Owner of House #6 has indicated that the water level was about 4 feet above the normal WSEL (approx. at the door knob of his tool shed). Personal account may have exaggerated actual surge height.

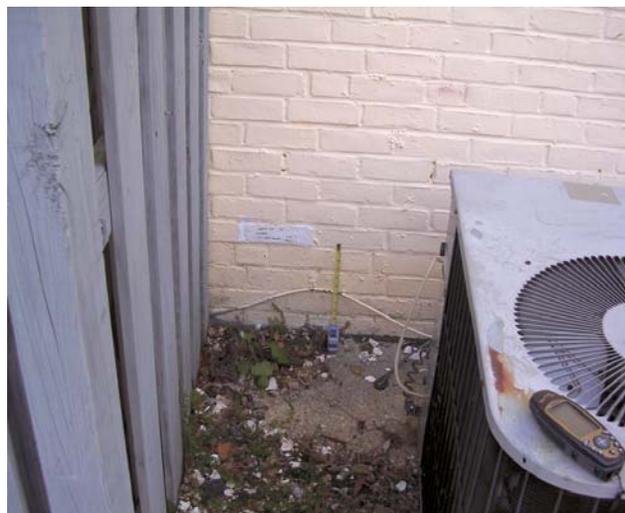
DSCN0014.jpg

Historical Mark: UNIT6_5 **Mark Type:** Coastal
Flood Event: Hurricane Isabel **Date of Flood:** 09/19/2003
Flooding Source: Spa Creek - Acton Cove **Quality of Mark:** Good
Flood Elevation: **4.9 FT** **Location:** Outside wall
Flooding Type: Surge
Mark Address: Waterfront Building - Burnside Street
Description of Mark: 1' above ground

Building numbers are not visible, except for unit number 301 of building east of Burnside Street. A red flag was tied at corner of wood fence for easy spotting. Mud line may have been affected by weather or cleanup action, resulting in lower than average elevation.

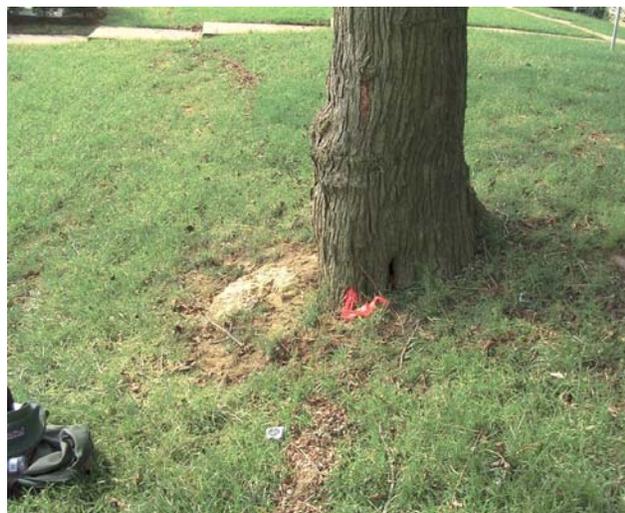
DSCN0016.jpg

Mark is also at the bottom of the 2nd concrete step down from the back of building #680

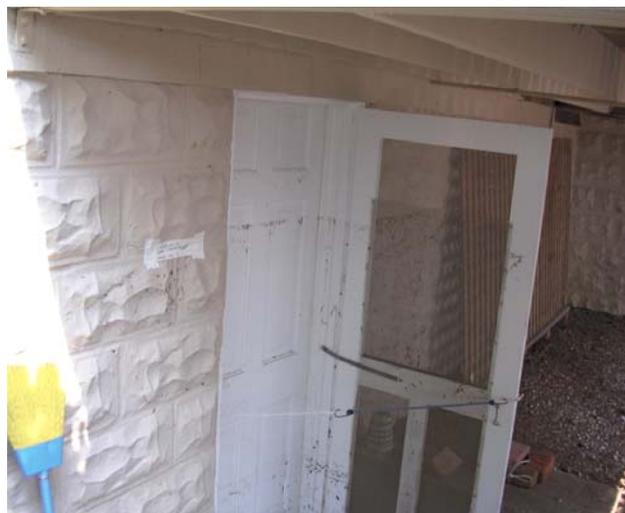
DSCN0021.jpg

Mudline is visible on the back wall and door to basement / crawl space
